Appendix D:

Foundation Laboratory Testing

ITRB investigations for the Cadia NTSF embankment failure are discussed in Appendix C. Samples collected as part of these investigations included:

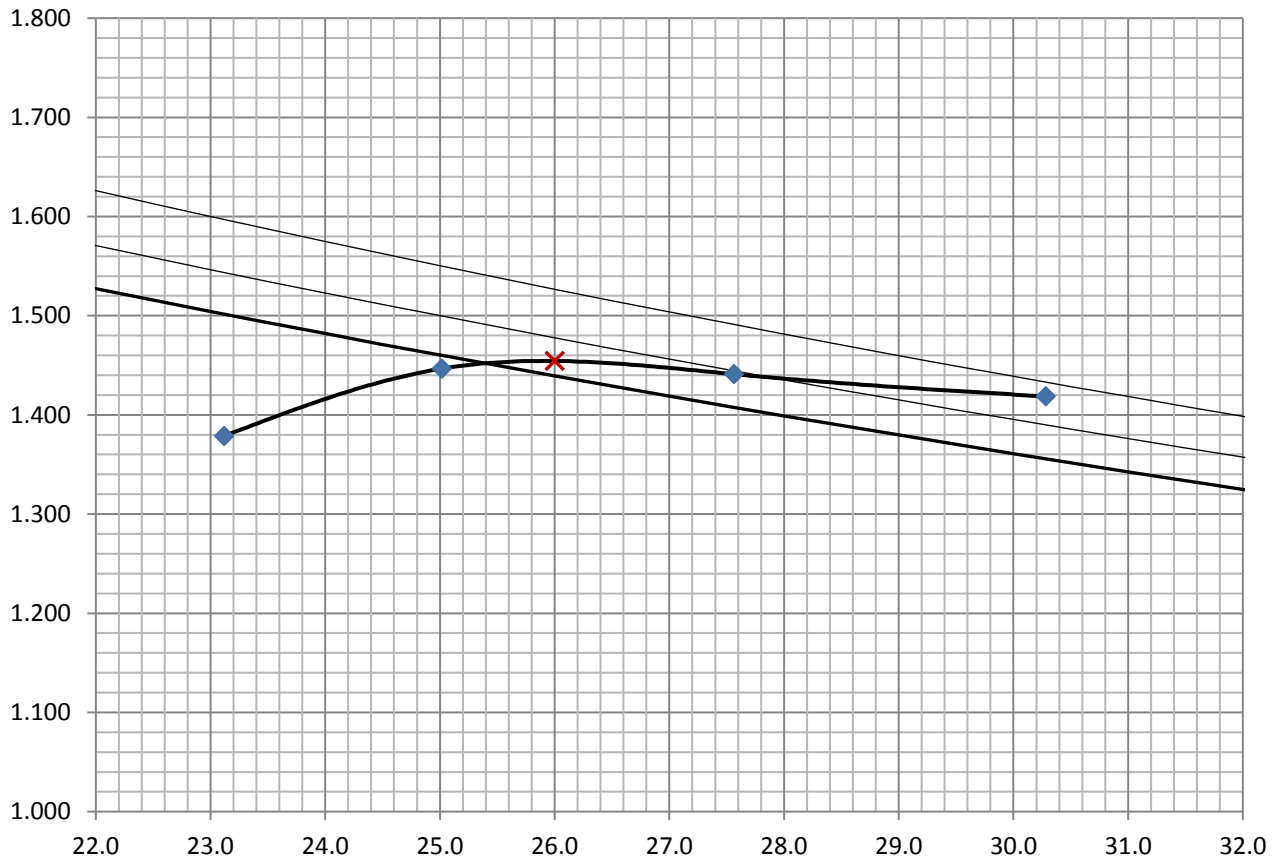
Zero Air Voids for Particle Densities 2.3, 2.4 & 2.5 t/m³

Maximum Dry Density 1.45 t/m³
Optimum Moisture 26.0 %

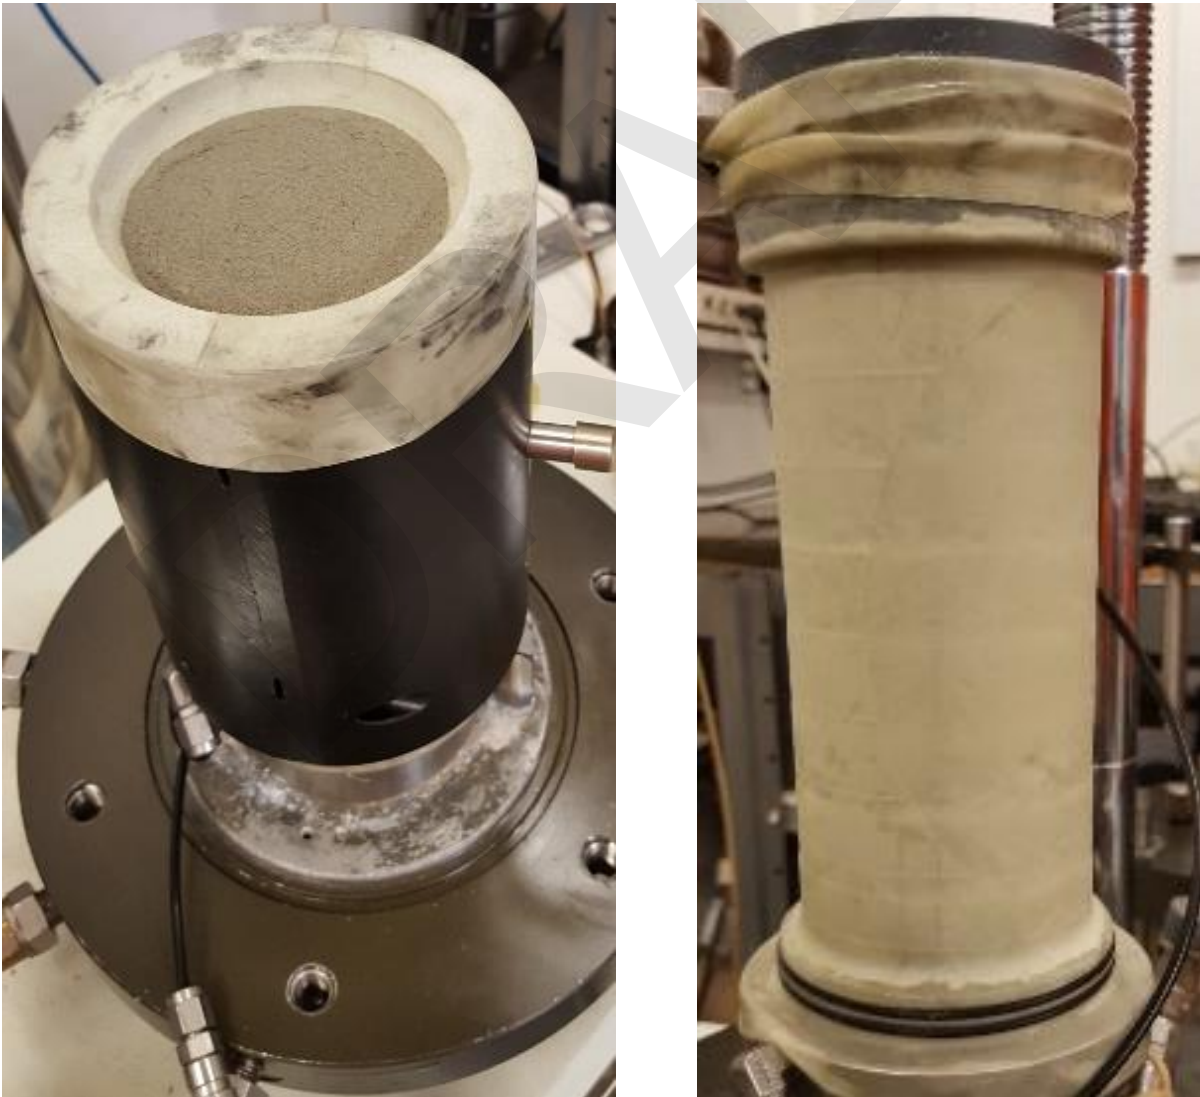
Figure 6: Split moulds with membrane under suction (left) and during specimen preparation with scarified layer prior tamping of next layer (right)

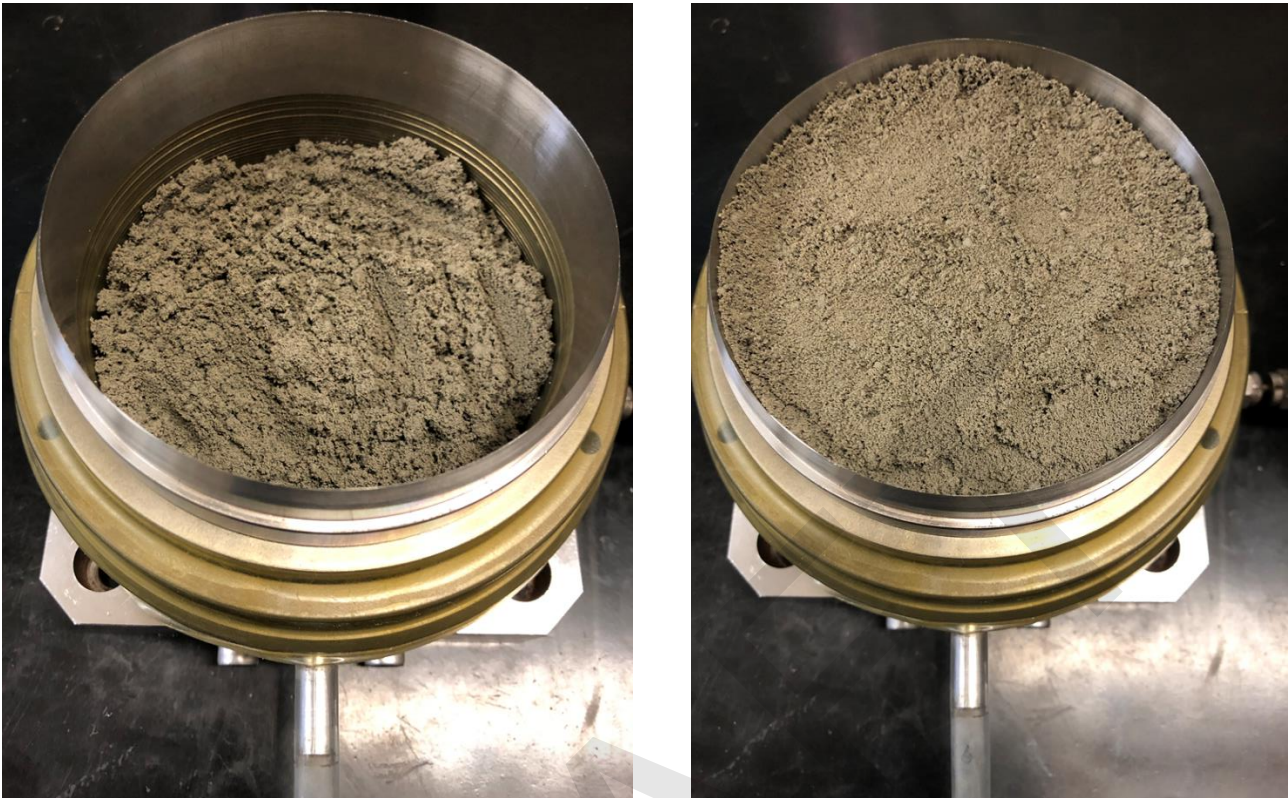
Figure 2: Placement of loose sample in DSS mould with stainless steel ring used to facilitate material placement

The specimen preparation procedure is shown in Figure 2 to Figure 5.
